Manhole Inspection Summary

Manhole # S130O1017MH

Insp Date: **11/29/06 11:00 AM**

Location Address: **2708 WOODLAND AVE**

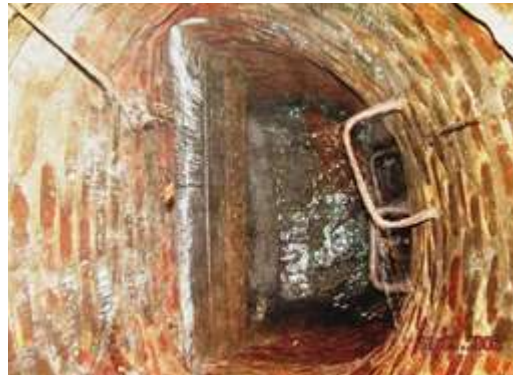
Top View

Adjsutment, Corbel, and Barrel infiltration. Corroded steps. Evidence of surcharge - Bench debris.

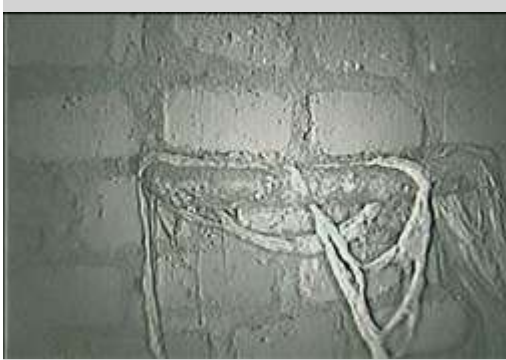
Evidence of surcharge

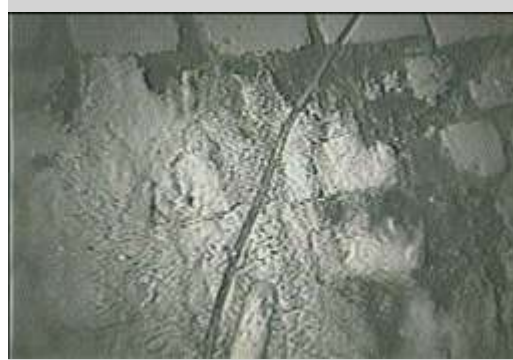
Defect

Barrel infiltration.

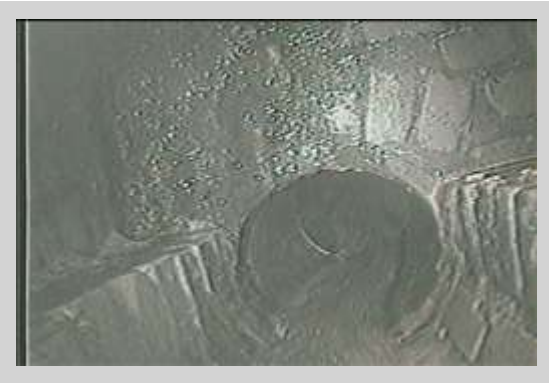
10 in. Circular Gravity Sewer Pipe Out @ 12 O'Clock

Infiltration: **None** Pipe Seal Cond: **Unknown**

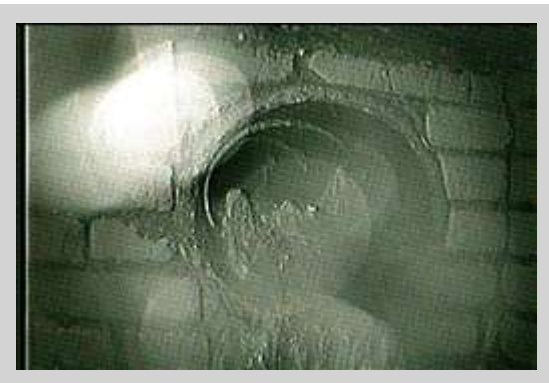
10 in. Circular Gravity Sewer Pipe In @ 6 O'Clock

Infiltration: **Evidence** Pipe Seal Cond: **Unknown**

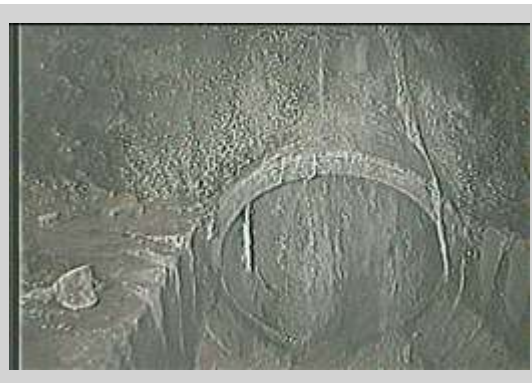
Drop In @ 6 O'Clock

Drop Condition: **Partly Clogged**
